Addressing issues of epidemiological disaster: observations on the Delmas water-based crises 1993- 2007

Document Information	
Document Version Number	Version 1.0
Document Type	Research Report
Short Title	Delmas epidemiological disaster 1993-2007
Long Title	Addressing issues of epidemiological disaster: observations on the Delmas water-based crises 1993-2007
Applicability	Delmas and surroundings
Status	Draft 0 for NDMC comment (not language edited yet)
Main Contributors	African Centre for Disaster Studies Niche Research Area: Cultural Dynamics of Water
Author(s)	Prof. EJ Nealer, ¹ Mr. E Bertram, ² Prof. E van Eeden, ³ Prof. D van Niekerk ⁴ , Prof. J Tempelhoff ⁵ , and Mr. C Coetzee ⁶
Date of this Compilation	June 2009
Contact information	Dewald.vanNiekerk@nwu.ac.za
Client	South African National Disaster Management Centre
Copyright	© 2009 South African National Disaster Management Centre

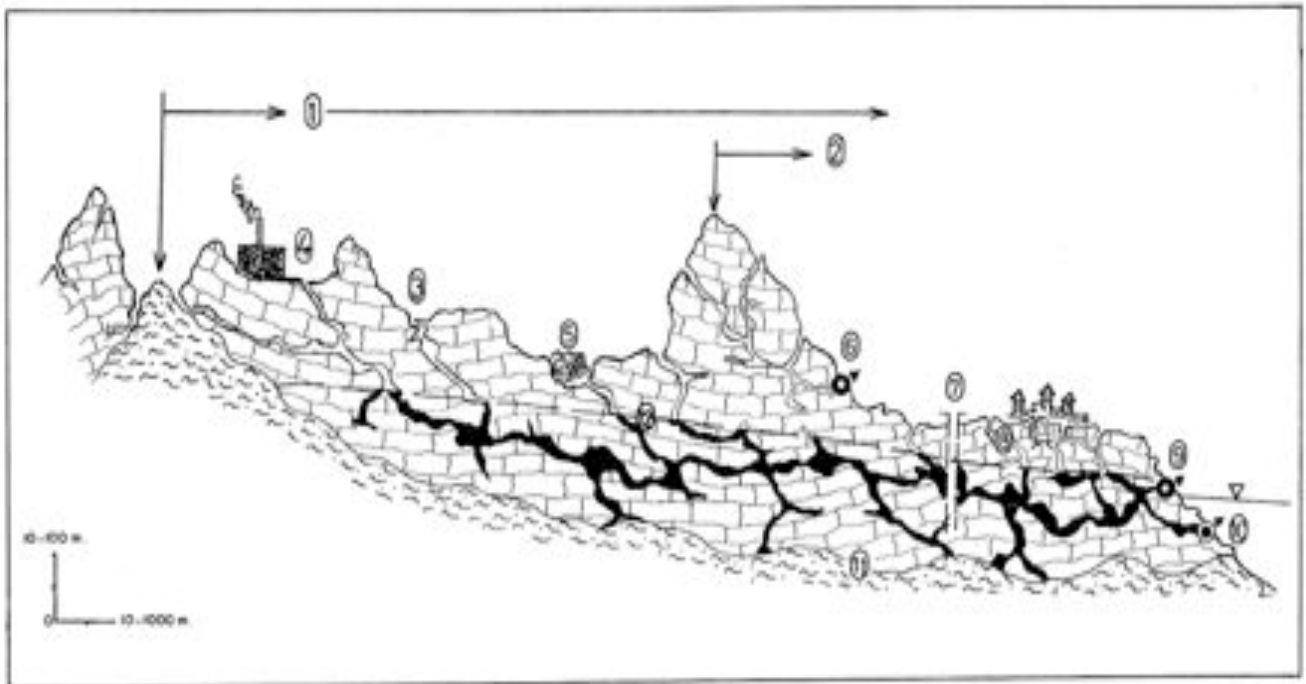
Figure 3: Karst features and utilization of the dolomite aquifer for water supply and waste disposal

(1) boundary of underground watershed, (2) boundary of surface drainage area, (3) ponor (swallow hole), (4) disposal of industrial waste water into a ponor, (5) solid waste disposal into a karstic depression, (6) karst spring (with limited watershed area), (7) water well, (8) disposal of municipal waste water into karst aquifer, (9) karst spring, (10) submarine karst spring, (11) base of karstification (impervious basement).

The geo-hydrological properties of the underground dolomite rock formations are determined by geologic and geo-morphological controls such as structure, stratigraphy and morphology. The water-bearing properties of the dolomite stem from carbonate dissolution along structural and litho-logical discontinuities such as faults, fractures, joints and bedding planes. The formations of the dolomites are distinguishable based on their chert content. The chert poor formations weather evenly to produce a low storage potential residue of silty clay. The chert rich rock formations weather quite differently. The dolomite weathers faster than the chert leaving the rock supported by chert structures. Eventually the chert will weather and collapse under its own weight leaving a permeable coarse chert breccia and unfortunately, sinkholes. Chert rich formations develop a greater concentration of fissures and fractures which will enhance the process of weathering. These chert rich formations are generally favourable for large-scale identification, development and abstraction of groundwater. See Figure 3 hereunder (Compare Mthethwa, 2008):

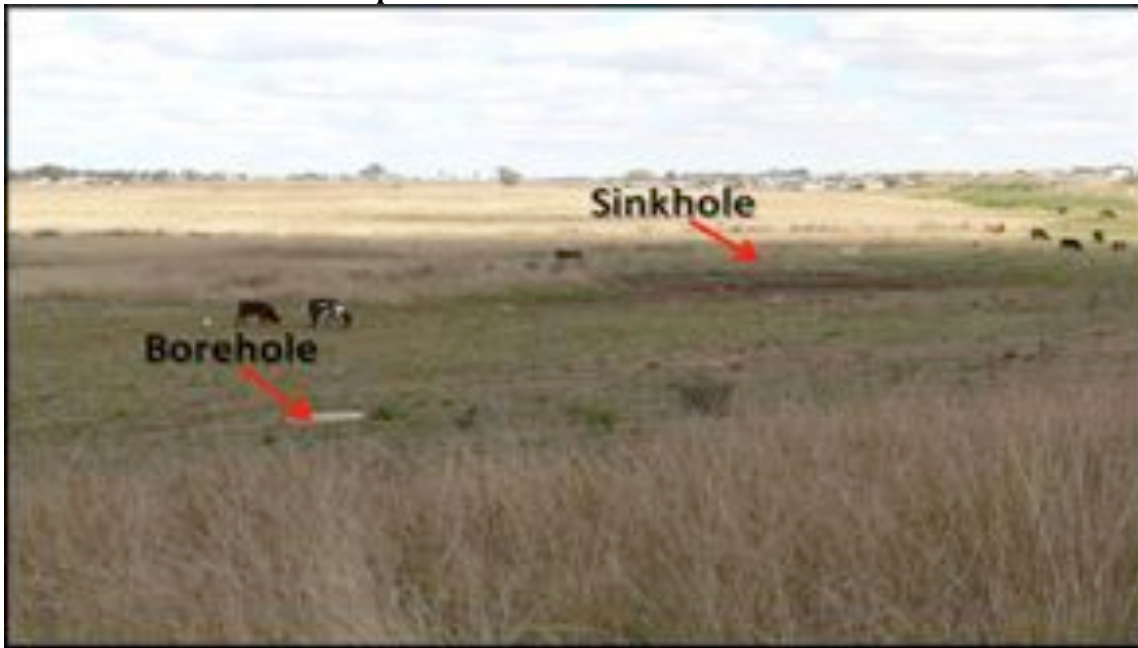
Photo 1: Sinkholes in the dolomite bedrock area immediately south (up-stream) of the A-field potable water abstraction boreholes

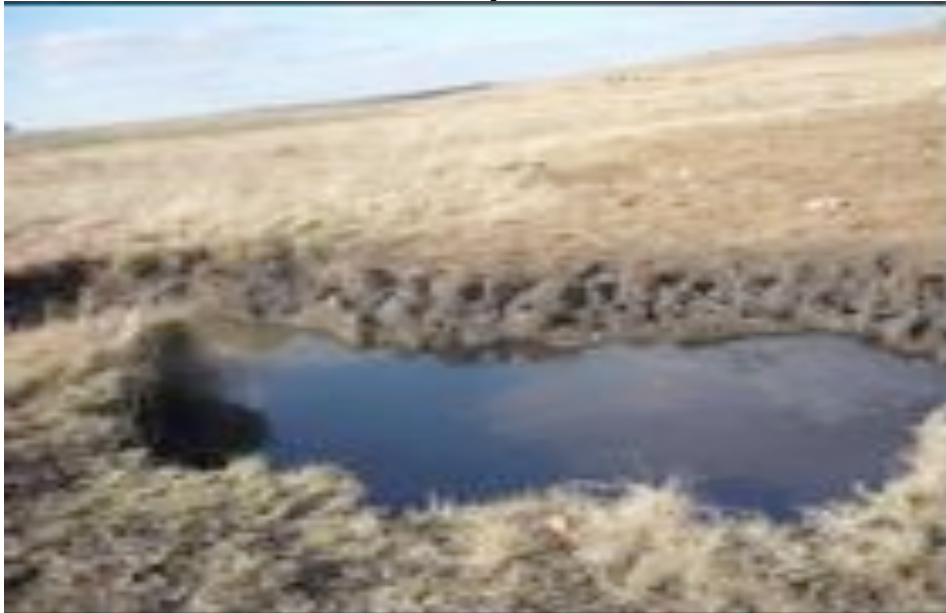
Photo 2: Sinkhole in the vicinity of the A-field boreholes

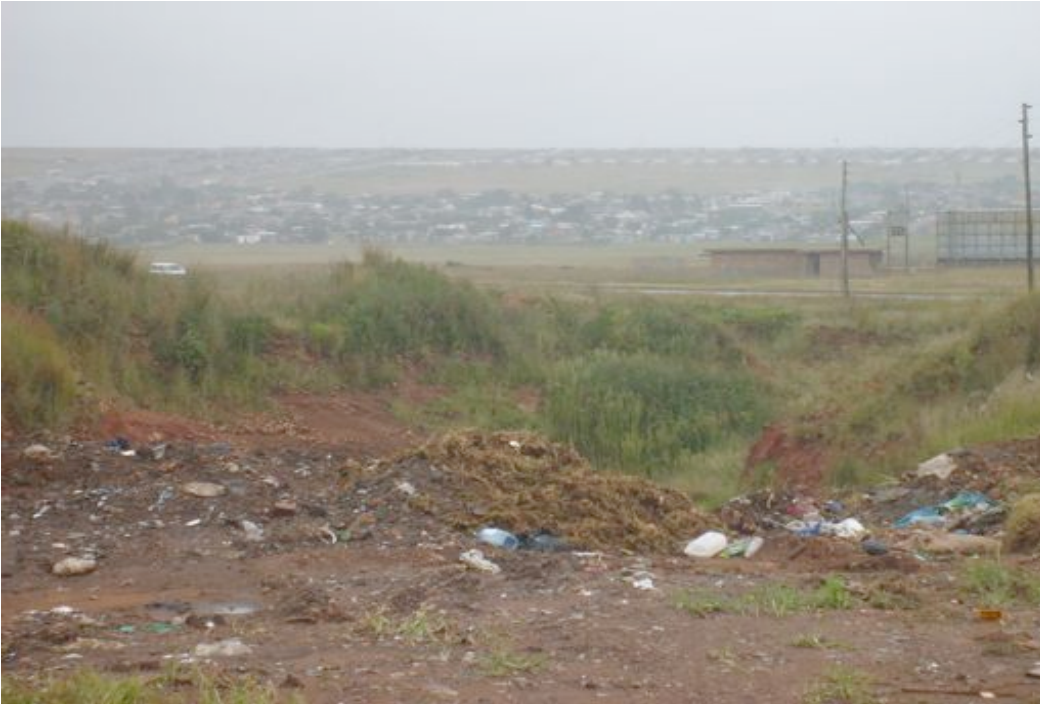
Photo 3: Refuse dump area immediately up-stream of the B-field potable water abstraction boreholes

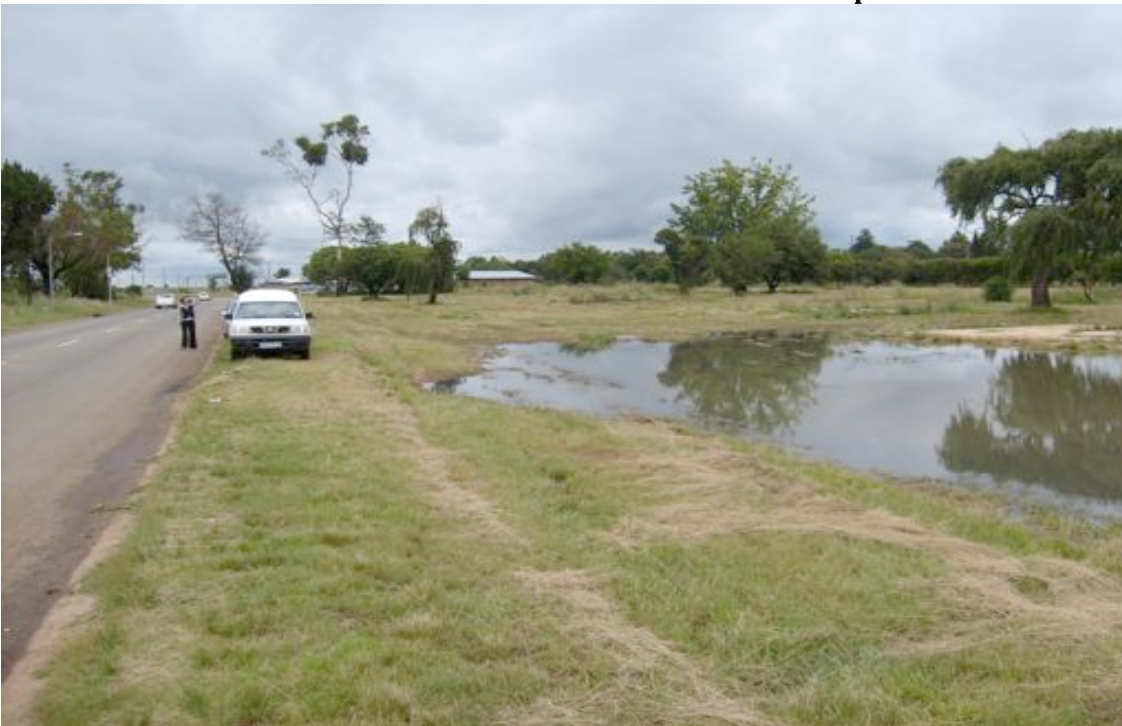
Photo 4: Small dam of raw sewage on the ground surface near the D-field potable water abstraction boreholes and 300m from the Municipal Offices in Delmas

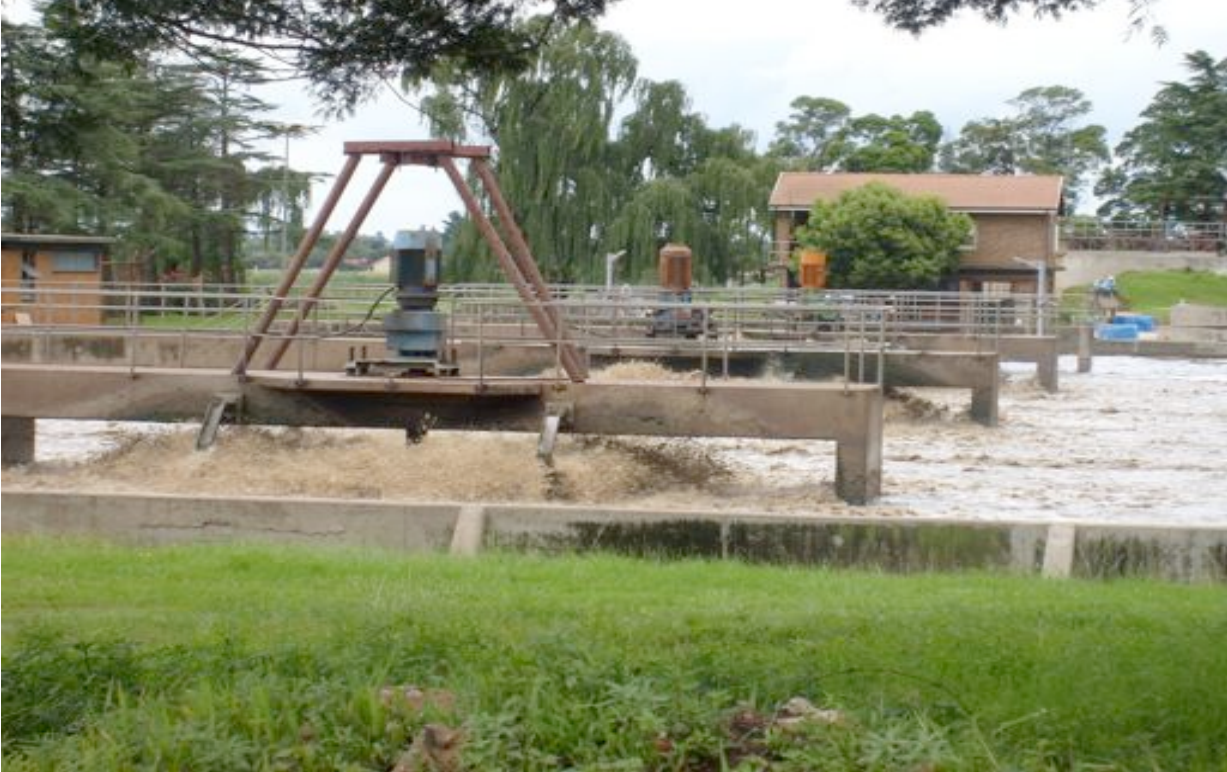
Photo 5: Overflowing older waste water treatment facility on the northern side of Delmas

- The under-performance of the Town's two WWTFs should be regarded as the direct cause for the unhygienic conditions that exist in and around the Delmasloop that flows through the centre part of Delmas and past Botleng Proper. This is also a major contributor to the deterioration of the groundwater quality in the A well field dolomite aquifer. The Municipality is compelled to:
